TECHNICAL REPORT  
69-49-CE

A STUDY OF FORCES CAUSED BY HEAD IMPACT ON  
AIRCREW PERSONNEL ARMOR UNDER SIMULATED  
CRASH CONDITIONS

November 1968

Clothing and Personal Life Support Equipment Laboratory  
U. S. ARMY NATICK LABORATORIES  
Natick, Massachusetts 01760

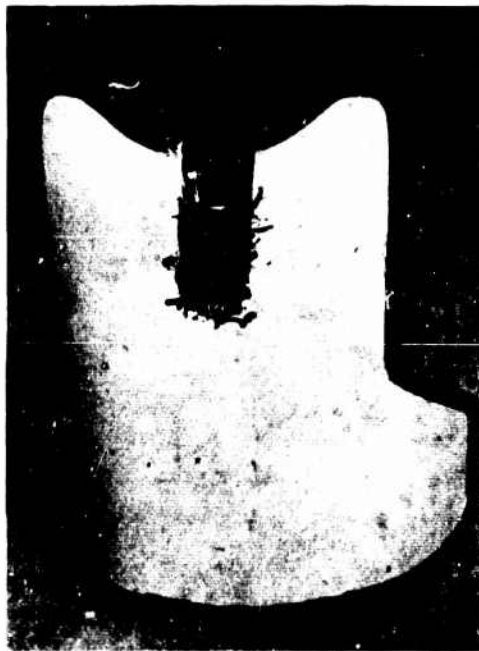
Figure 2. Front Armor Plate with Load Cell Installed.

To record the data required by the program objective, a piezoelectric load cell was installed flush with the top edge of a chest armor plate. A portion of the armor was cut away in this area and the load cell, mounted on a steel bracket, was attached to the armor using Epon 901/B-1 adhesive. Figure 2 shows the completed installation. Additional data on the load cell are found in Appendix B, Instrumentation. This modified armor plate was used in both the standard aircrew protective armor and the new combination flak/small arms protective vest.

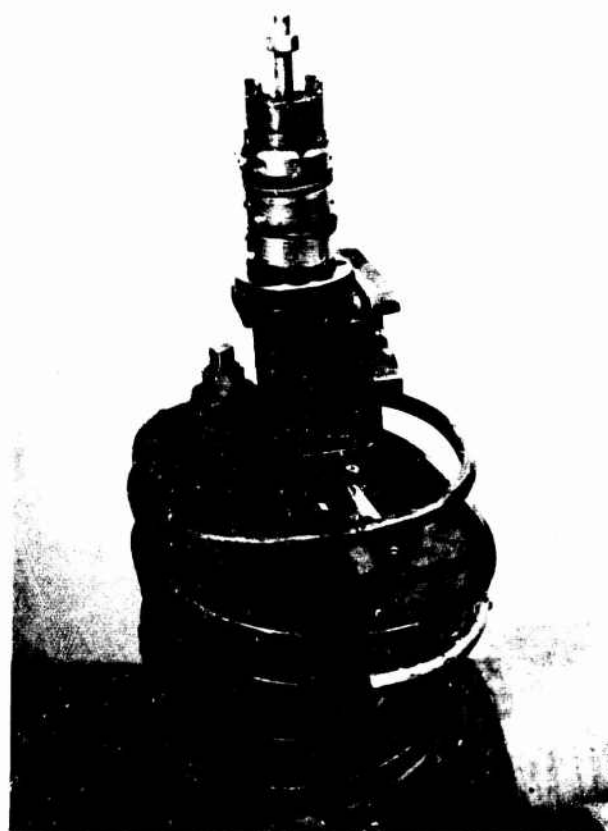
Figure 4. Replacement Neck Vertebra Assembly.

To improve the human simulation characteristics of the anthropomorphic dummy, several modifications were made. The first modification was to improve the neck vertebra assembly. The original neck vertebra assembly consisted of a series of steel vertebra strung on a steel cable as shown in Figure 3. With this arrangement, the only way to adjust the resistance of the neck to motion was to adjust the tension on the cable. Such adjustment also varied the maximum rotation of the head. The replacement assembly consisted of a series of individually adjustable ball and socket joints separated by compressible rubber washers. Figure 4 shows this new neck assembly installed on the dummy. Adjustment of resistance in each joint is accomplished by adjusting large Allen screws projecting from the rear of each joint. Tightening these screws forces a friction pad against the ball of each joint, producing simulated muscle resistance without limiting head rotation.

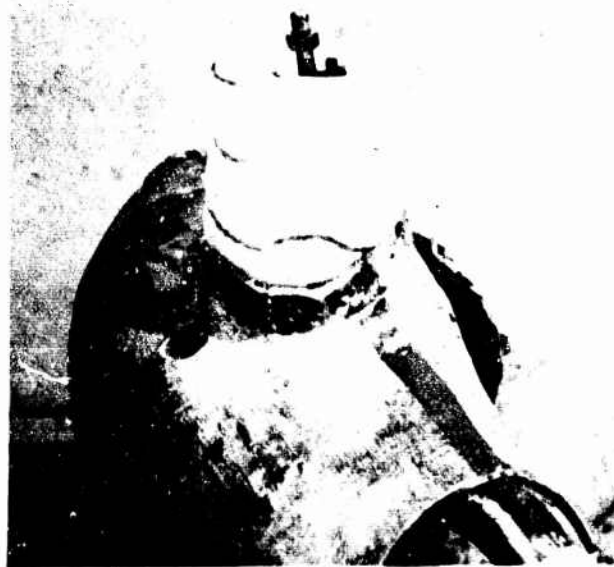
Figure 5. Foam Rubber Padding Installed on Neck of Anthropomorphic Dummy.

The configuration of the dummy neck was also found to require modification. In its original form, the neck consisted of a thick rubber skin covering the vertebra assembly. A steel collar was used to join this neck skin to the body skin. Obviously, this combination of steel collar and rubber skin would present a poor simulation of the dynamic response of the human neck in the event of neck/armor impact during the tests. Since no definitive data were available concerning the force-displacement characteristics of the human neck, it was not possible to design an exact simulation. The simulation was improved by removing the steel collar and installing foam rubber padding over the vertebra assembly as shown in Figure 5.

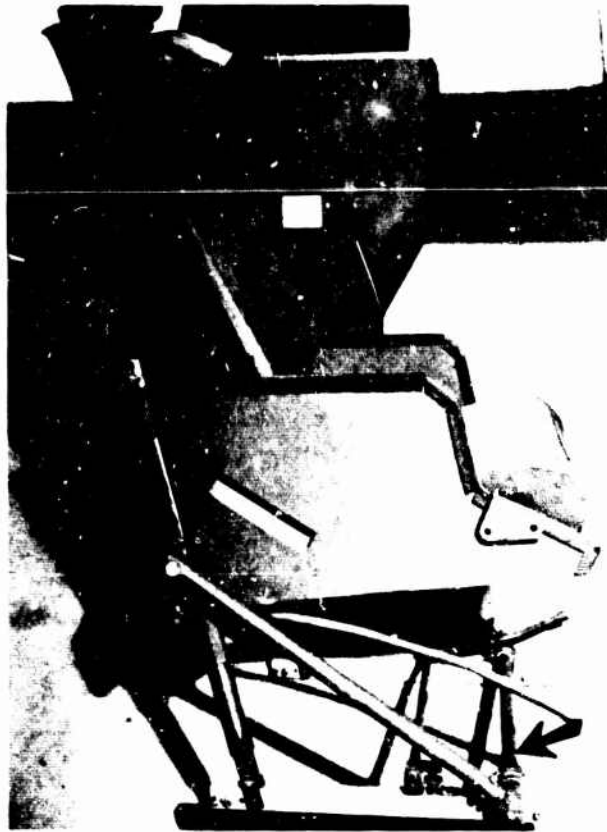
Figure 10. Side View of Modified UH-1B/D Seat.  
(Arrow indicates front cross member  
made of solid steel 4130 bar stock that  
replaced the original steel cross tube.)

During the dynamic tests, the front cross tube, made of thick-alled chrome-alloy steel, was found to be subject to bending failure and was replaced by a solid bar of 4130 steel (Figure 10).

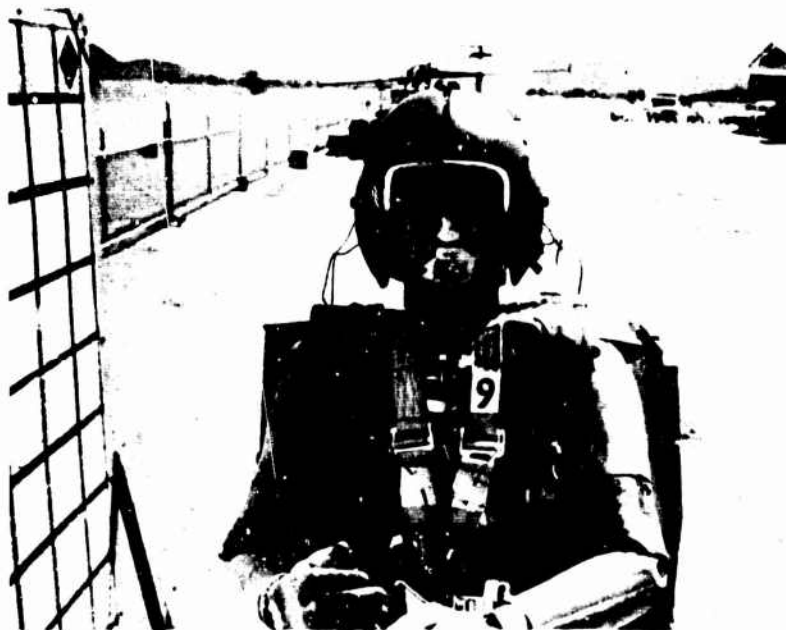
Figure 14. Combination Flak/Small Arms Protective Vest.

The new combination flak/small arms protective vest (Figure 14) is similar to the standard protective armor. The chest and back armor plates are the same ceramic coated fiberglass material used in the standard protective armor. The carrier, however, contains heavy padding intended to stop low-velocity fragments. For these tests, only the chest armor plate was used with the carrier. Total weight of the vest with chest armor plate was 19 pounds.

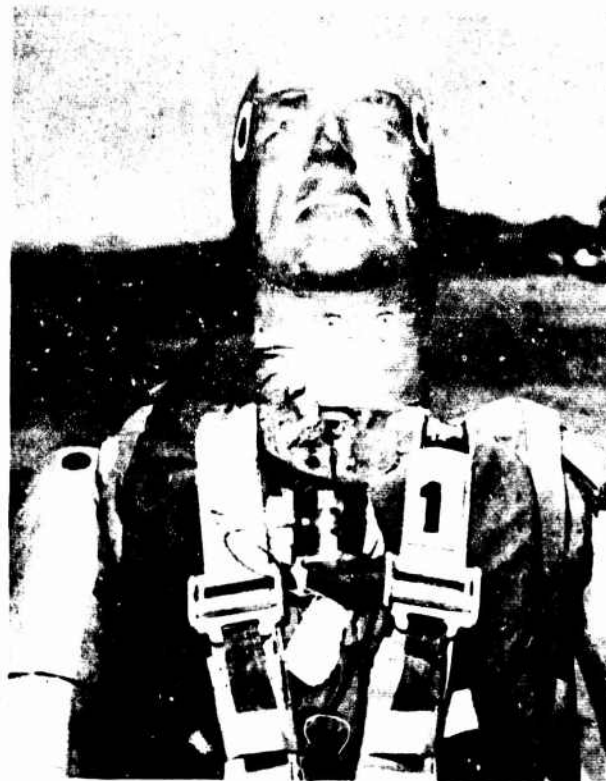
Figure 19. Dummy Fitted With Standard Aircrew Protective Armor for Tests 1 Through 4.

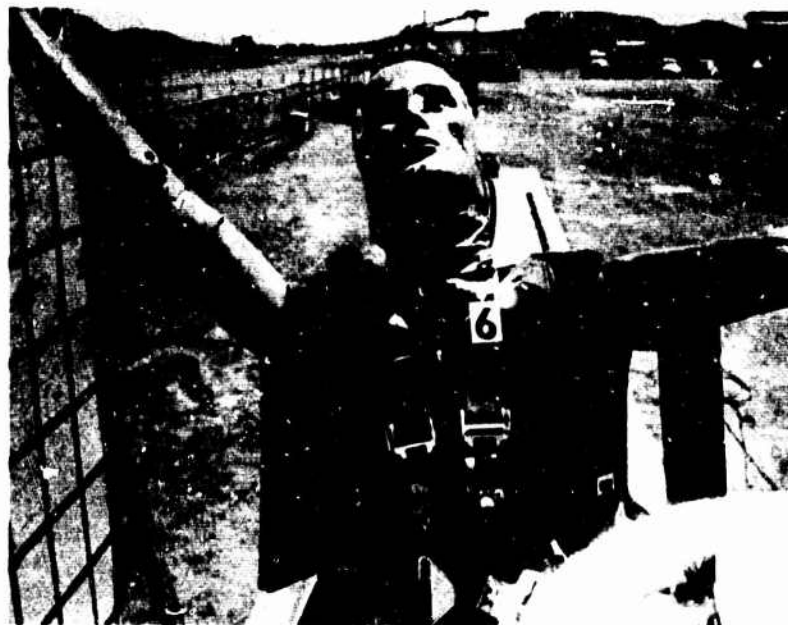
Figure 24. Posttest View - Test 6.  
(Black mark on chin is contact point.)

Some difficulty was experienced with helmet retention during this block of tests. The nape strap failed during Test 6, allowing the helmet to come completely free. The nape strap was replaced with a length of 1-inch wide webbing, which performed fairly well for the remainder of the tests. Again, no significant difference in head accelerations was noted between the tests in which head/armor contact occurred and the one test where no contact occurred.

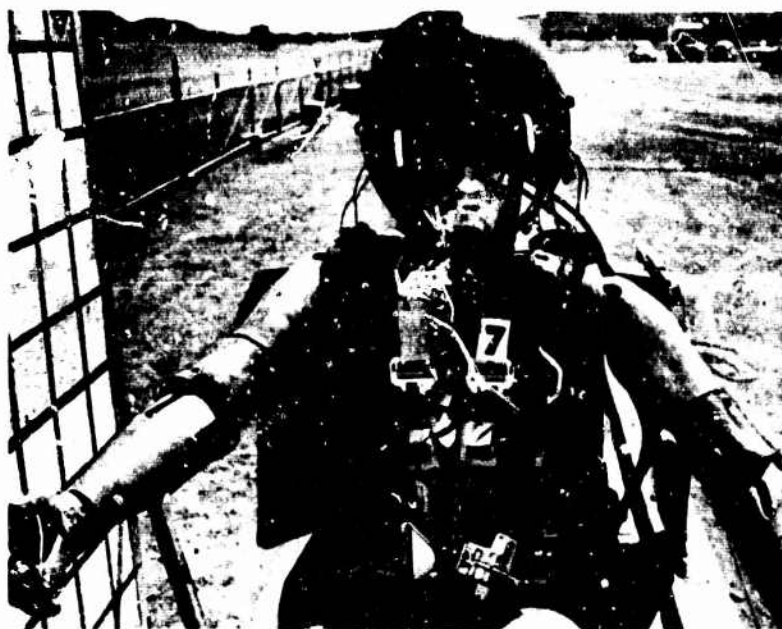
Figure 25. Chin Load Trace - Test 6.

loads of about 80 pounds. The resulting traces and posttest photographs showing impact locations are shown in Figures 23 through 27. No post-test photograph is available from Test 5.

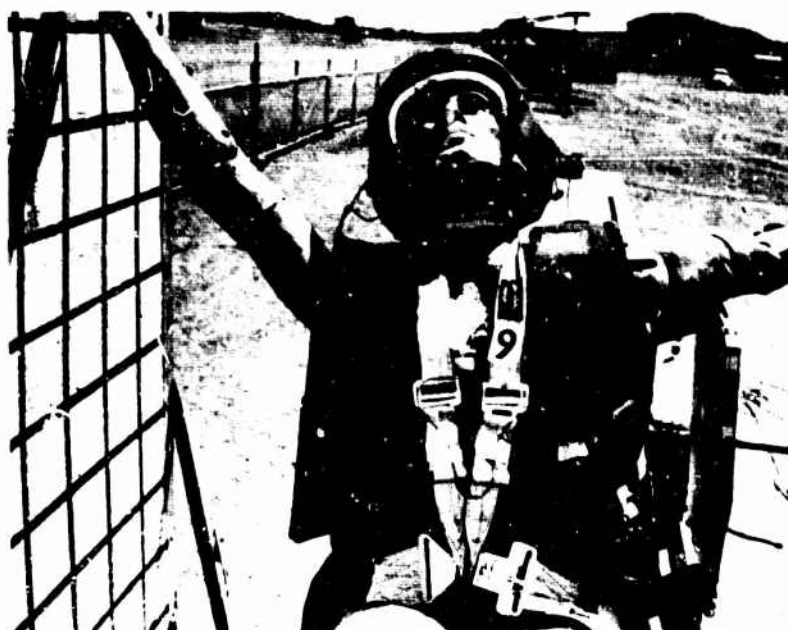
Figure 28. Posttest View - Test 9.  
(Black mark on chin is contact point.)

Figures 28 through 33 show posttest views and load traces from the tests involving head/armor contact.

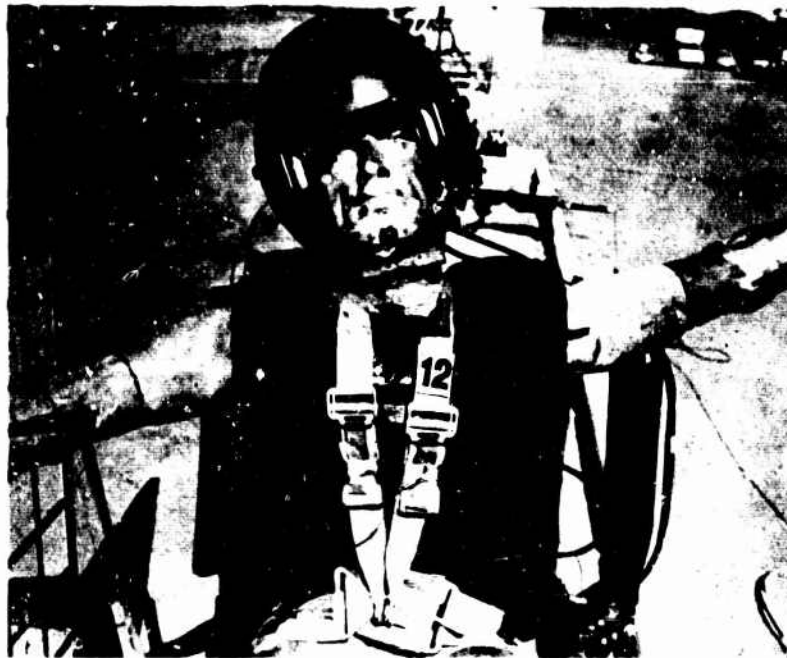
Figure 32. Posttest View - Test 12.  
(Black mark on chin is contact point.)

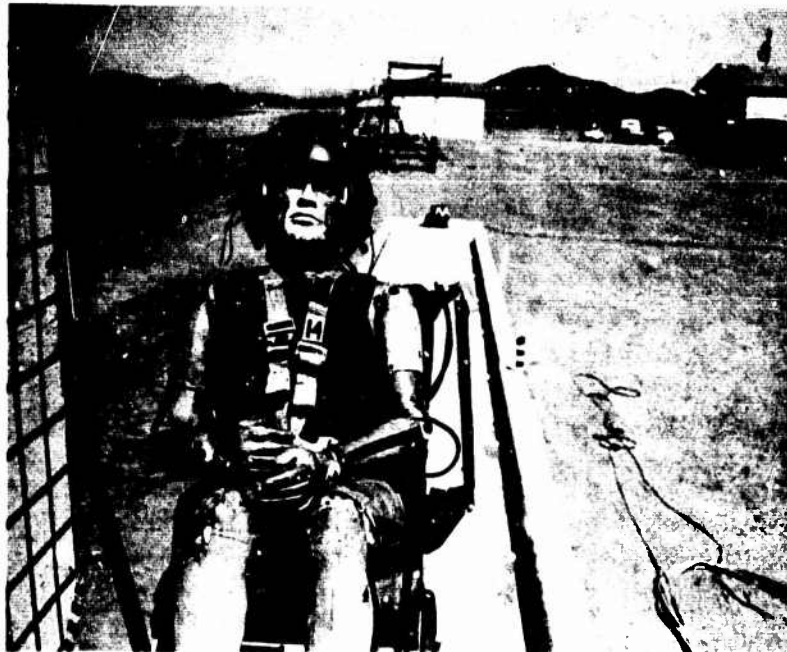
Figure 78. Pretest Front View - Test 14.

In Test 13, the straps were placed around the sides of the armor, while in Test 14, the straps were passed over the top of the armor. Figures 77 and 78 show pretest front views of Tests 13 and 14.

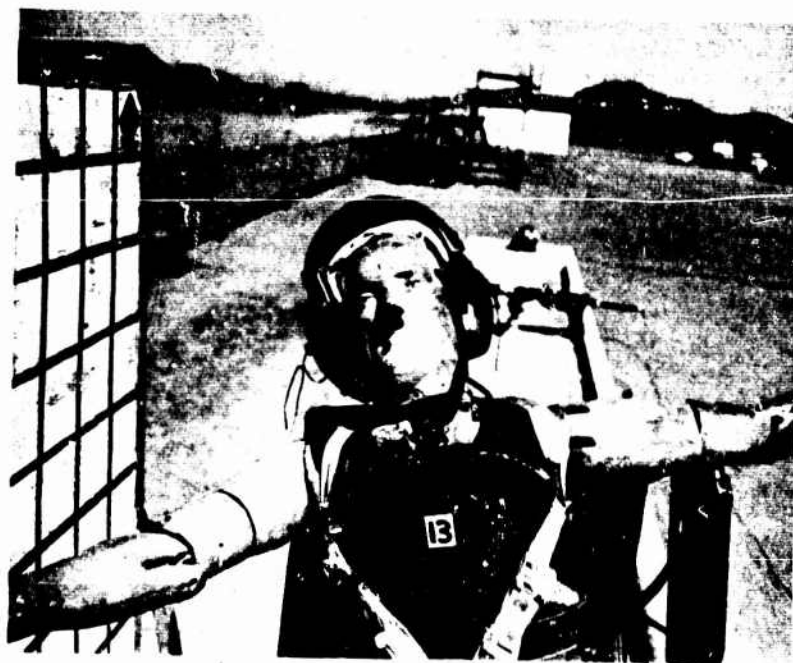
Figure 79. Posttest Front View - Test 13.

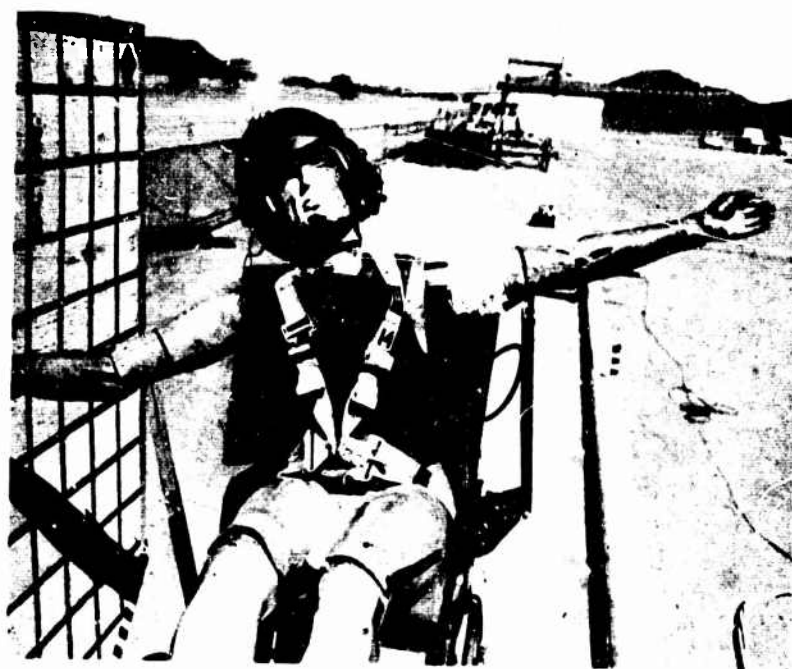
Figure 80. Posttest Front View - Test 14.
